Property Inspection Report

5619 Osbourne Dr, Windsor, CO 80550

Date of Inspection: 3/18/2022 Time: 9:00 AM

This is a 5 point home inspection covering roof, structure, electrical, plumbing, HVAC

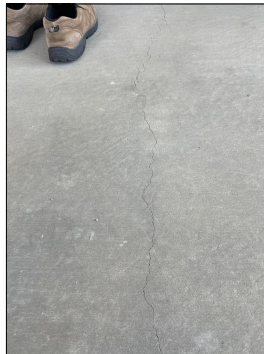
- Improve: Typical cracking was observed at the concrete surfaces. Further deterioration will occur as water expands and contracts from freeze and thaw cycles. Recommend sealing the cracks to prolong the life of the concrete. First sweep the cracks very well with a broom then blow them out with air. Next install backer rod in all cracks greater than 1/4" wide. Finally, fill with a good exterior self leveling concrete caulking such as SitkaFlex sold at Home Depot stores or MasterSeal NP1 sold at Ace Hardware stores.

Typical expected cracking noted

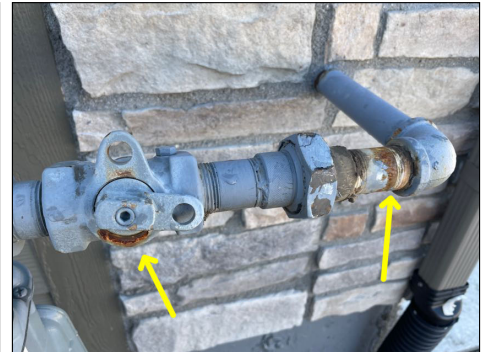
- Meter located at exterior, meter appears to be in good serviceable condition. No gas odors detected.
- **"DEFICIENCIES / CONCERNS"**
- Corrosion / rust noted on the gas meter and supply lines. Rust is a cancer for metal and will lead to accelerated deterioration. I recommend cleaning the corrosion / rust off the metal in the near future and painting the pipes and meter as necessary to extend longevity.

Corrosion / rust on the gas supply lines is a concern

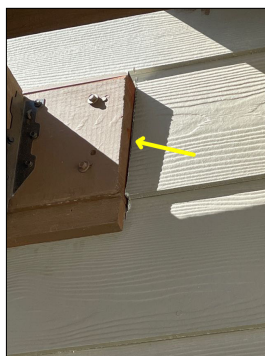
Seal / caulk

- Maintain all exterior brick finishes: Install caulking, and other sealants at any dissimilar material abutments and all penetrations, holes, or gaps to the walls and roof. This inexpensive task aids in the prevention of moisture intrusion and saves on costly repairs.

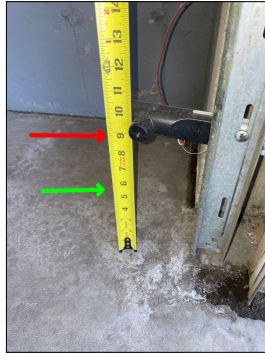
- **"OBSERVATIONS"**
- Garage vehicle door auto-reverse is functioning as intended.
- Eye beam system present and operating.
- **"DEFICIENCIES / CONCERNS"**
- Garage vehicle door eye beam sensors appear to be mounted higher than recommended standard height of within 6" of the floor. This safety feature is recommended for the occurrence of a child or adult laying down under the door the eye beam sensors would not pick up their presence and injury may occur. This is a safety and liability concern, we recommend contacting a licensed contractor for further evaluation and correction as necessary.

Eye beam sensors are too high for modern child safety standards

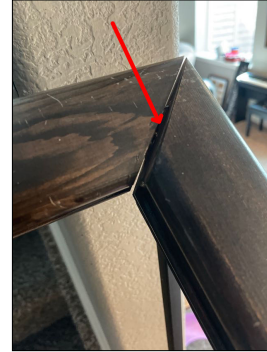
- Basement handrail is separating at a corner joint. Recommend contacting a licensed contractor for repair / correction as necessary.

Hand railing joint is separating

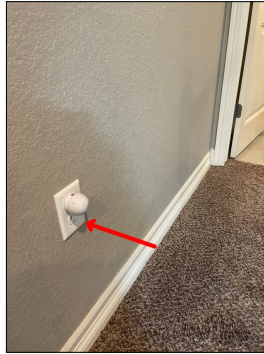
- **"SYSTEMS NOT TESTED"**
- All low voltage electrical lines, telephone lines, coaxial cables, WiFi, associated service panels and such are not inspected as they fall outside the scope of this inspection.
- **"ARC FAULT CIRCUIT INTERRUPTION PROTECTION"**
- Installed AFCIs responded to test and appeared in good serviceable condition at the time of this inspection.
- **"LIGHTS"**
- The light switches and lights were functioning as intended with no visible deficiencies noted at the time of this inspection.
- **"RECEPTACLES"**
- Most receptacles except where noted, are in good condition and found to be wired correctly.
- **"GFCI - GROUND FAULT CIRCUIT INTERRUPTER PROTECTION"**
- GFCI protected receptacles in place and functioning as intended.
- **Broken ground plug noted in one of the basement receptacles, please see picture. Recommend contacting a licensed electrician for correction.**

Bottom receptacle has a broken ground plug in it

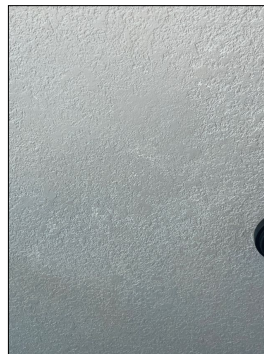
- The drywall is patched in areas, lighting has been upgraded. Consult with disclosure / current owner for any known details.
- The ceilings & walls were inspected with no signs of past or present leaks, dry at the time of this inspection.

Repairs noted

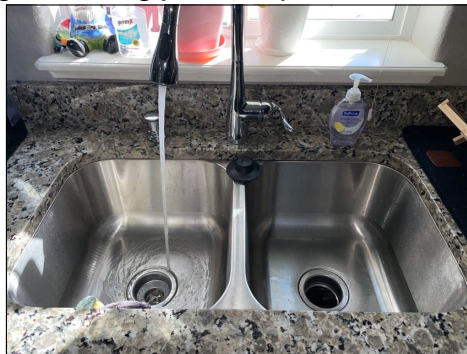
- **"SINKS"**
- Kitchen has a stainless steel - under mounted sink.
- **"DEFICIENCIES / CONCERNS"**
- Under mounted sink leaks along mounting joint. Repair as needed.
