Inspection Report

Property Address:
2037 Vancorum Cir.
Loveland CO 80538

Date: 6/26/2020	Time: 9:00am	Report ID: 2020.06.26a.2037
Property: 2037 Vancorum Cir. Loveland CO 80538	Customer: Shara Brumley Leeona Garlitz	Real Estate Professional: Brittany Sall C3 Real Estate Solutions - Sall Team

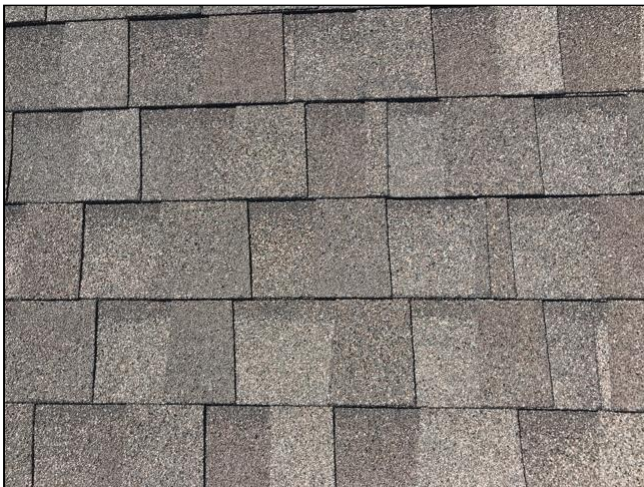
1.0 Item 1(Picture)

(1) At the time of the inspection the roof covering was in good condition. No deficiencies were noted.

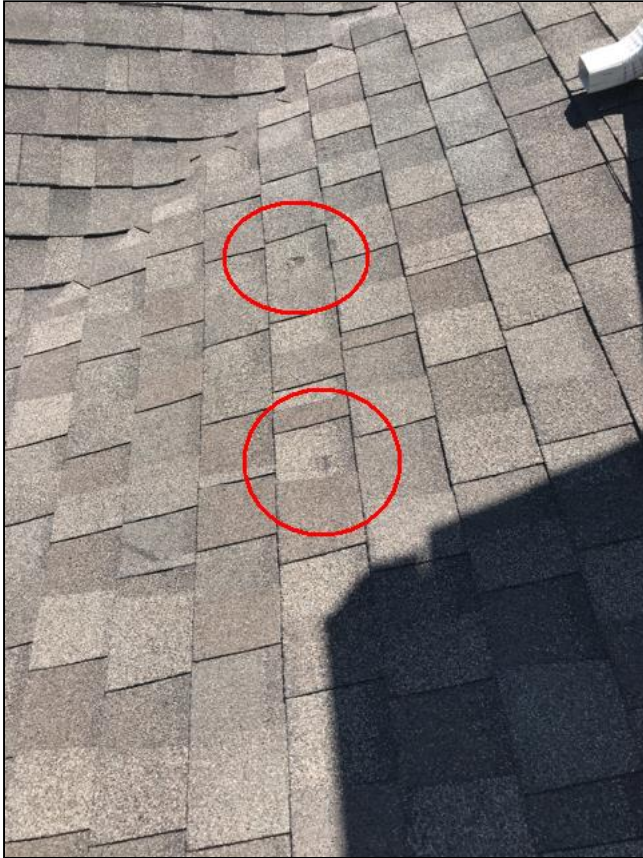
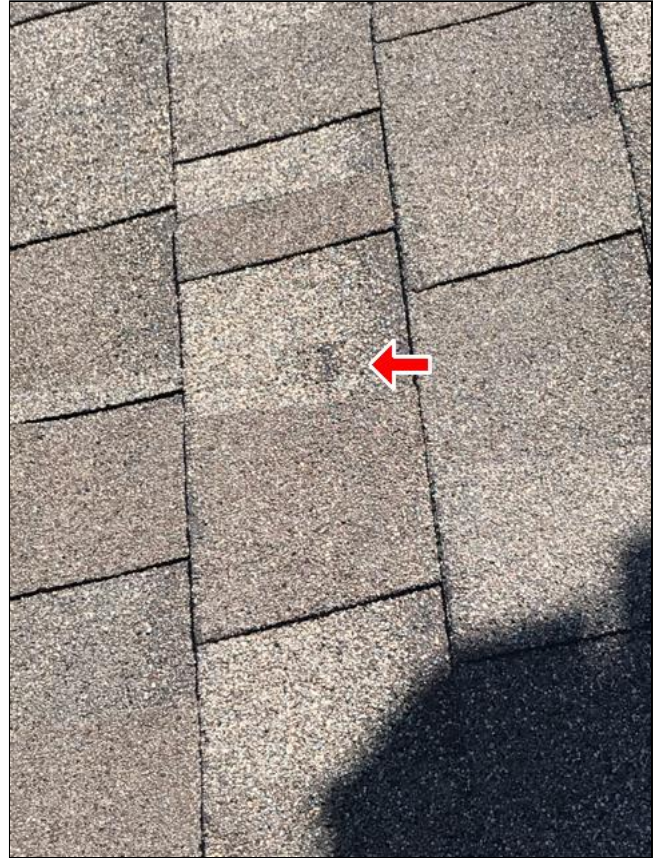
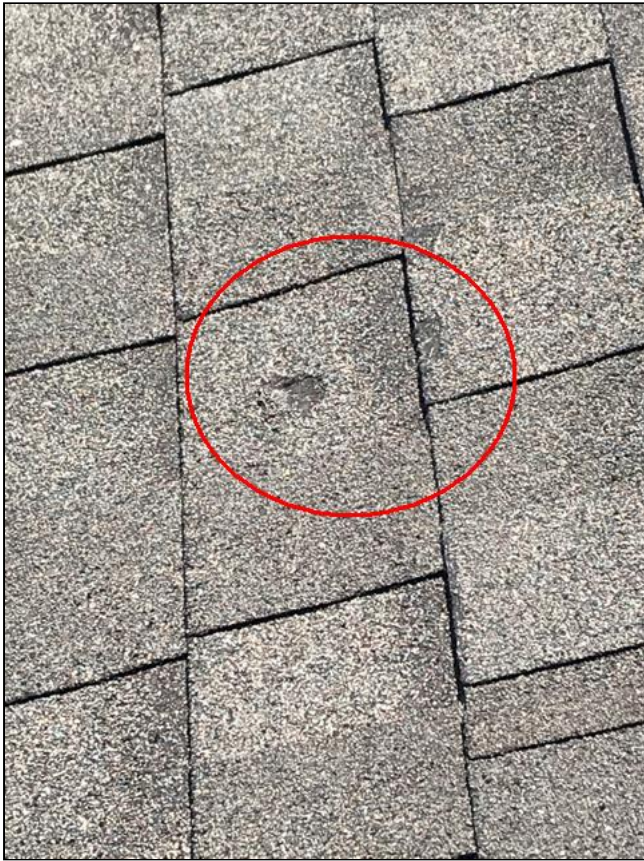
1.0 Item 10(Picture)

(2) There is some minor shingle damage from a ladder on the roof above the front porch. It is cosmetic and for your information.

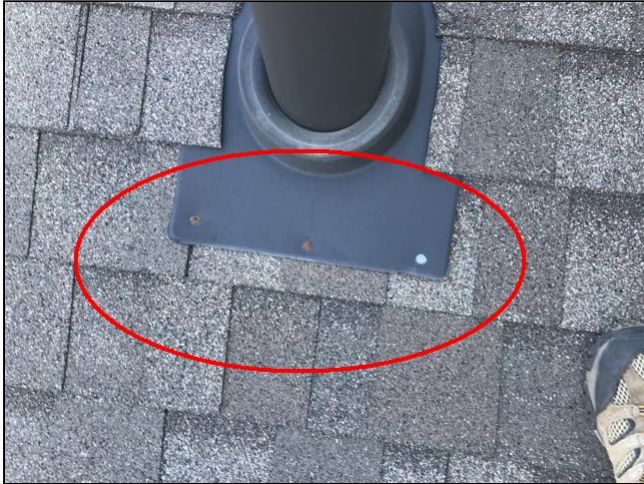
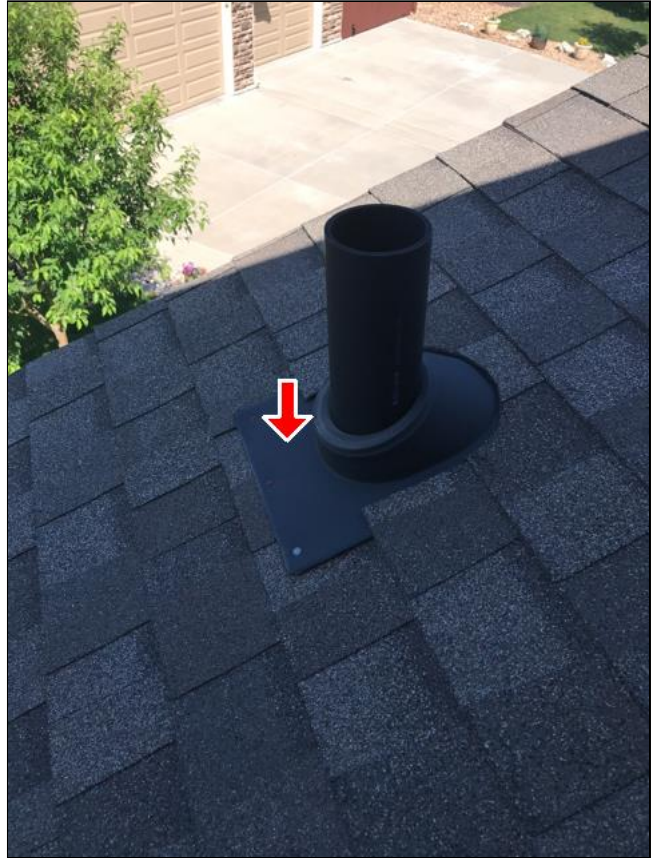
1.2 Item 1(Picture)

- 🏠 (1) There are exposed fasteners on the radon vent boot on the house roof. They need to be caulked with a quality roofing caulk.

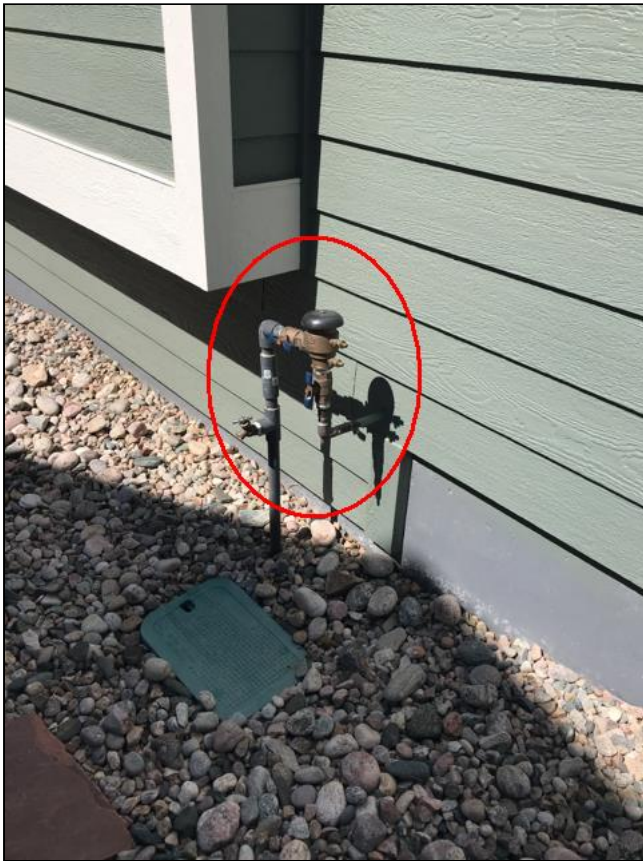
2.9 Item 1(Picture)

(2) Lawn sprinkler anti-siphon loop. This loop will need to be drained in the winter to prevent freeze damage. It is recommended that a qualified sprinkler service person blow out the sprinkler system.

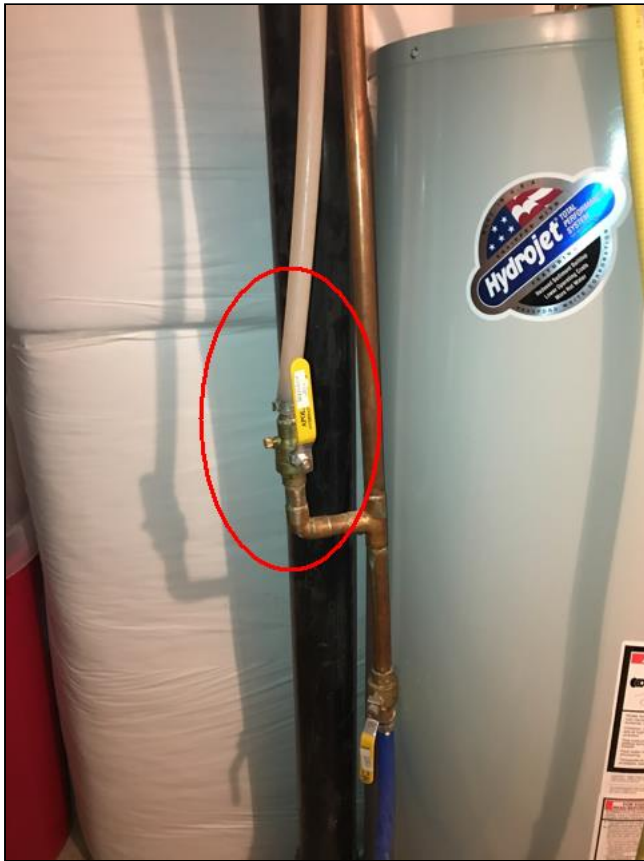
2.9 Item 4(Picture)

(4) The lawn sprinkler main water shut off (yellow lever handle) is located in the basement next to the water heater.

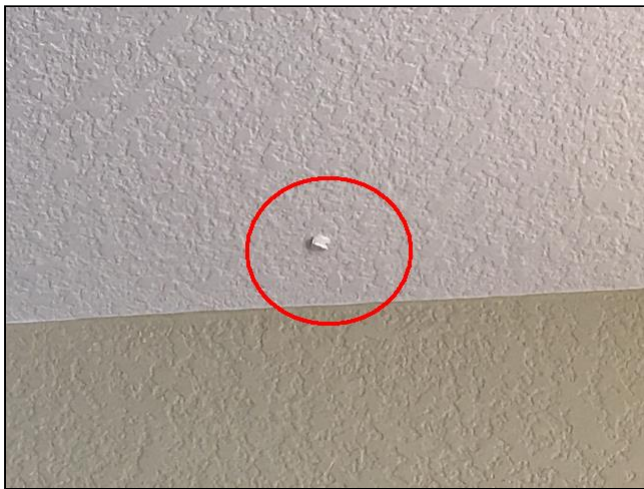
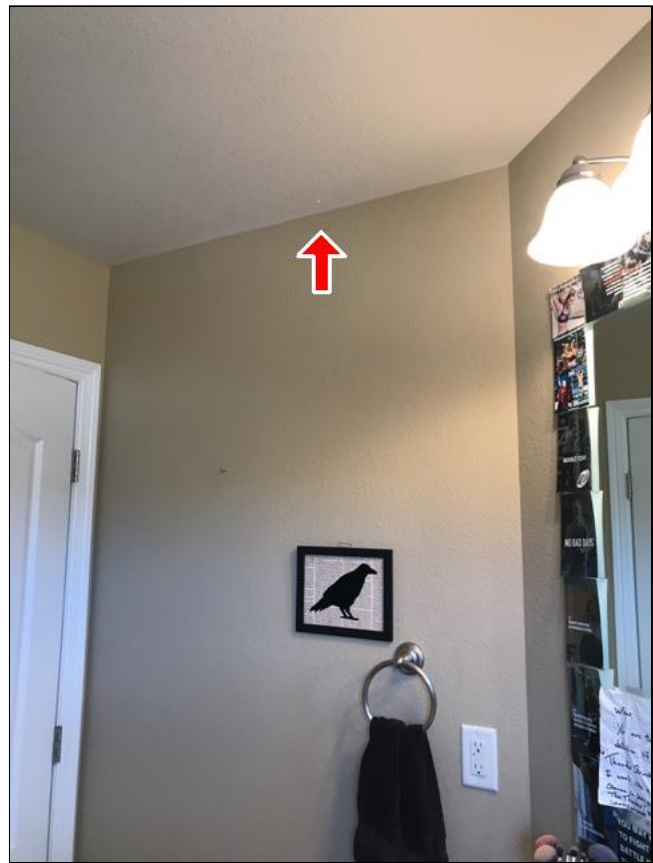
4.0 Item 1(Picture)

At the time of the inspection several drywall nail pops were noted in the upstairs hallway bathroom.

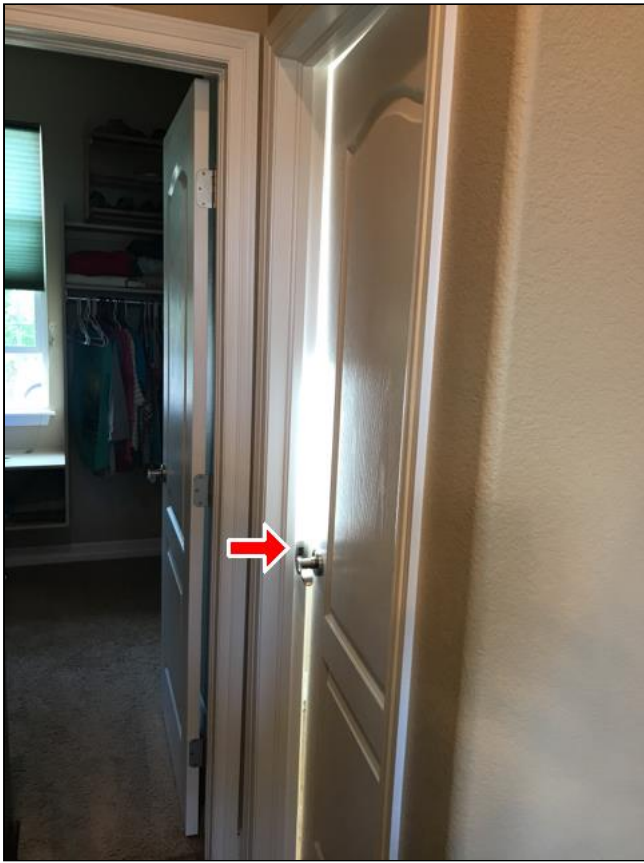
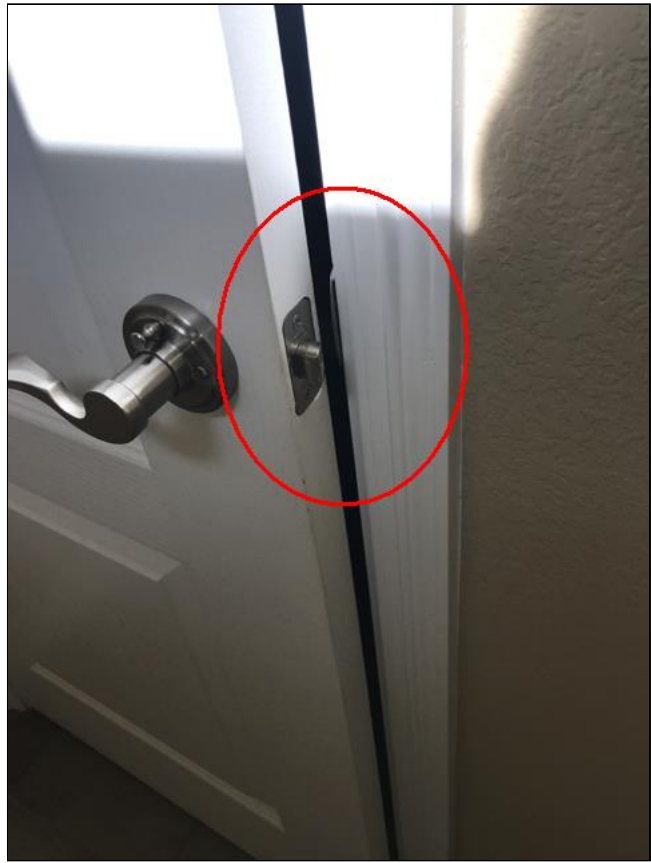
4.6 Item 1(Picture)

🏠 (1) Master toilet closet door(s) won't latch. The strike plate or top hinge needs to be adjusted to operate properly.

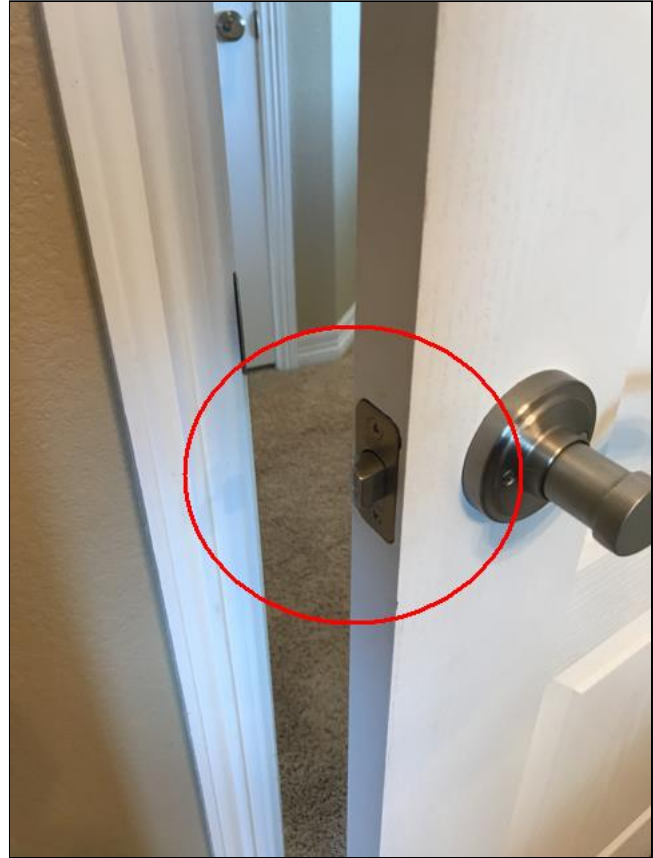
4.6 Item 4(Picture)

🏠 (2) Upstairs hallway bathroom door(s) won't latch. The strike plate or top hinge needs to be adjusted to operate properly.

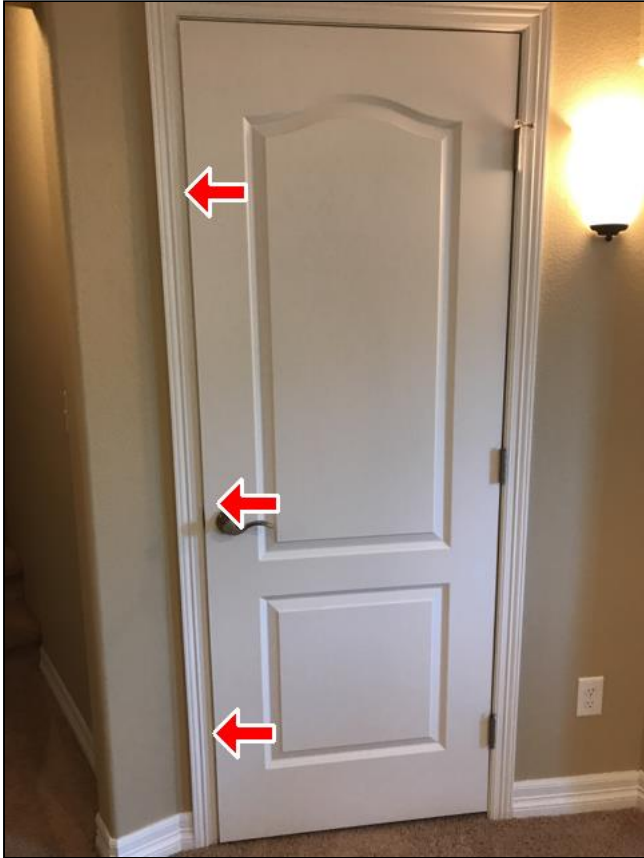
4.6 Item 5(Picture)

🏠 (3) Basement under the stairs storage closet door(s) rubs at jamb when operating. A qualified person should repair or replace as needed.

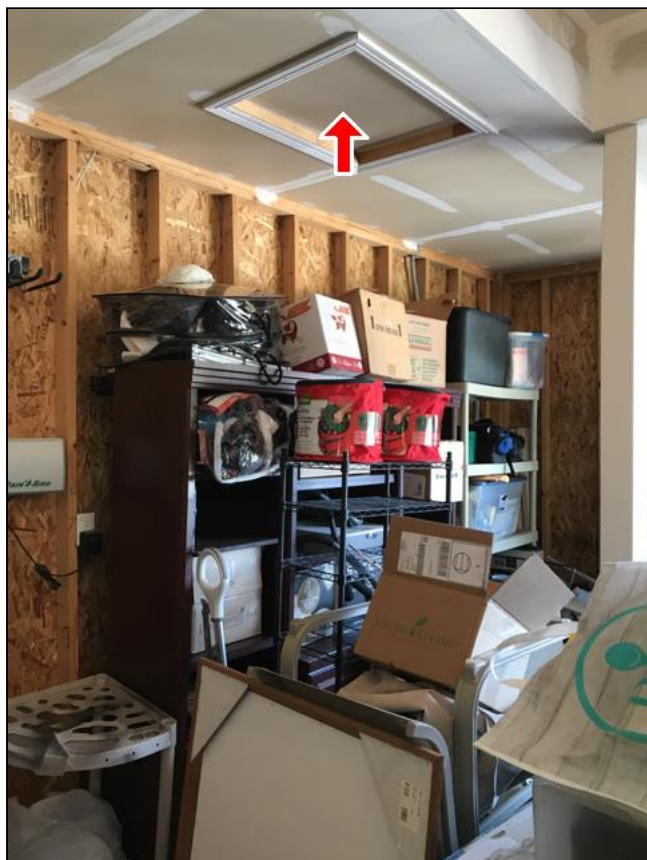
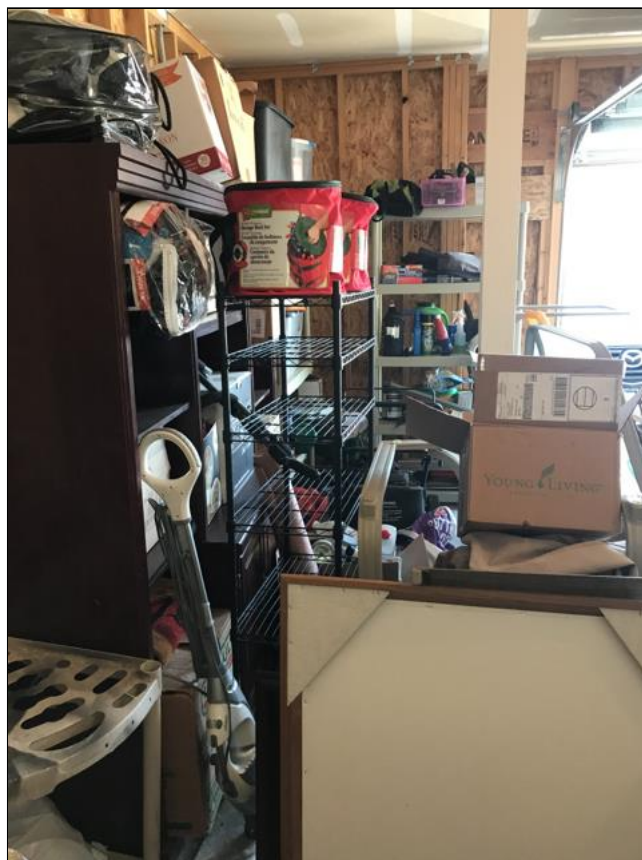
5.5 Item 7(Picture)

🏠 (2) The attic access in the garage was blocked by seller's personal property. I could not inspect the interior side of roof structure or insulation or any electrical in attic.

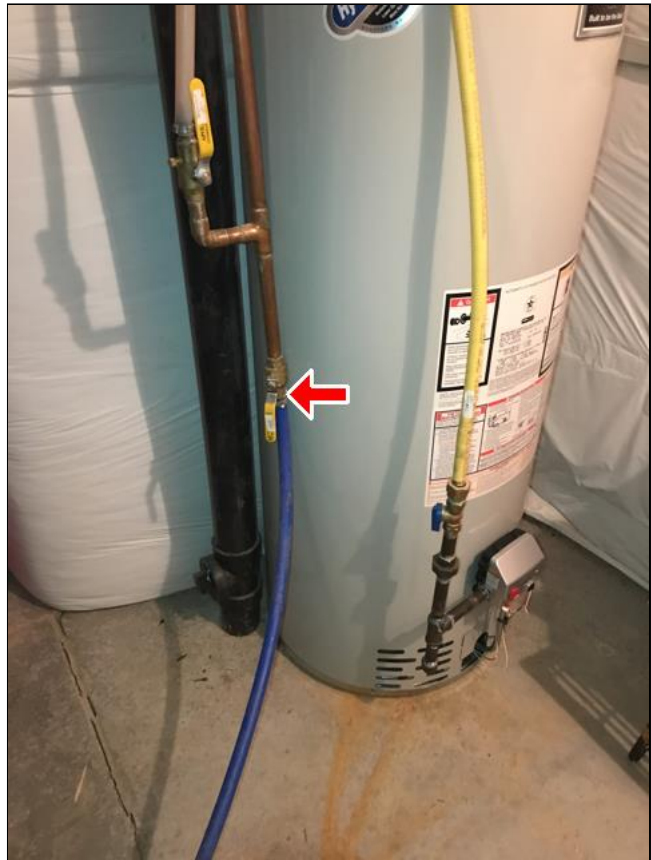
6.3 Item 4(Picture)

(3) The main water shut off is the yellow lever located in the basement at the furnace room beside the water heater. This is for your information.

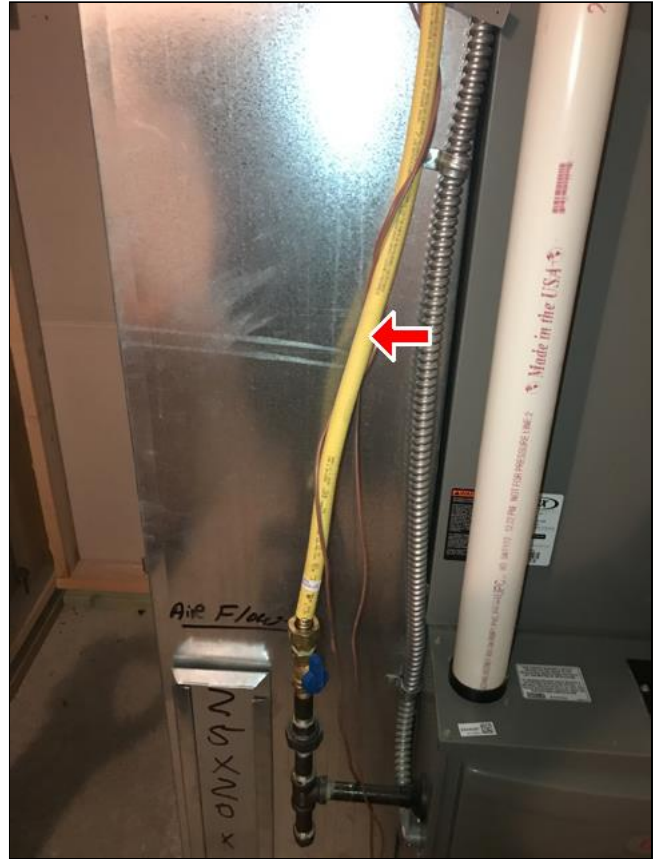
6.4 Item 1(Picture)

The subject property has yellow CSST (Corrugated Stainless Steel Tubing). There is a risk of fire from arcing due to power surges, lightning strikes or lightning in the surrounding area of the property, unless it is properly bonded. The CSST piping in this property has been bonded.

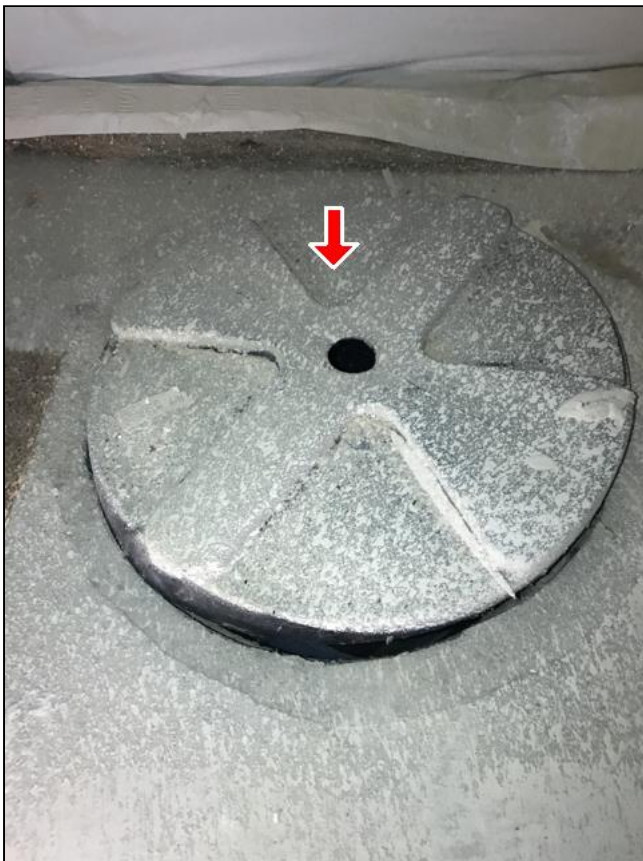
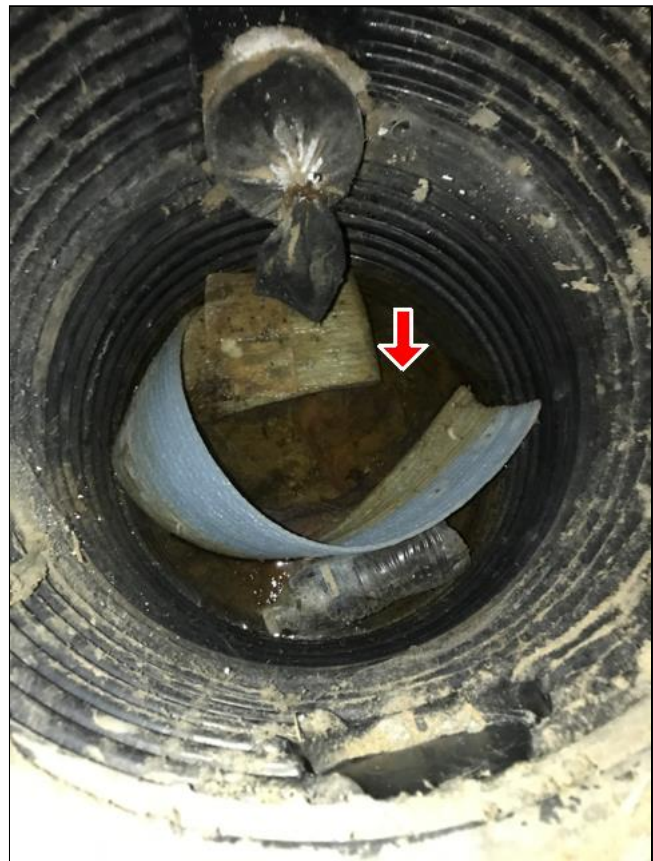
6.6 Item 1(Picture)

At the time of the inspection 4" of standing water and debris was noted in the sump pit and no pump was present. It is recommended that a pump be install and discharged to the exterior of the home. Discharge pipe needs to drain water 4-5 feet away from the home.

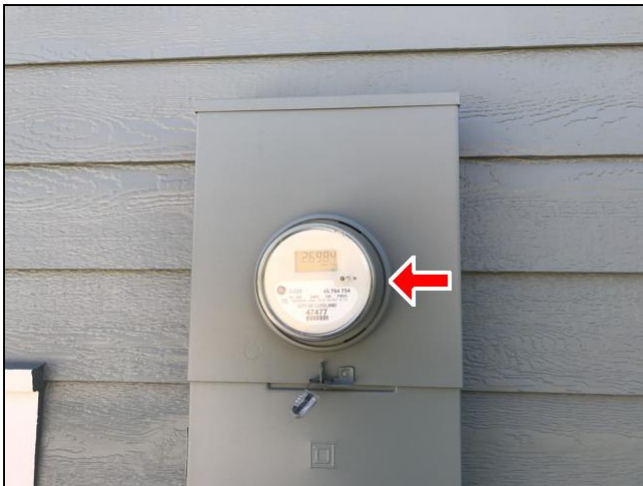
7.1 Item 1(Picture)

(1) At the time of the inspection there were no deficiencies noted in the meter panel.

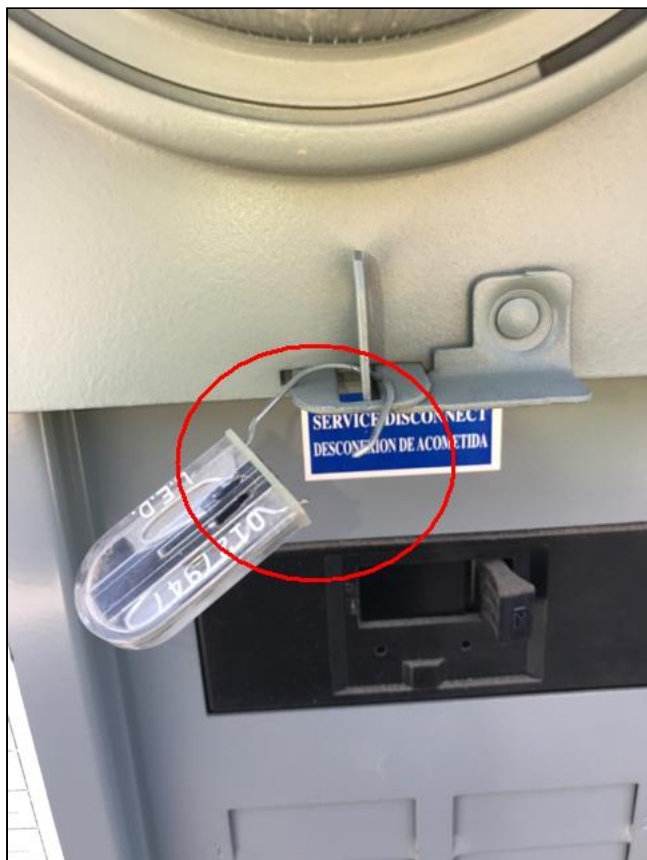
7.1 Item 10(Picture)

- ⚡ (4) The non-tamper clip on the meter housing has been clipped. I recommend that the Electrical Power Company be notified to inspect the meter and confirm that it has not been tampered with and install a new clip.

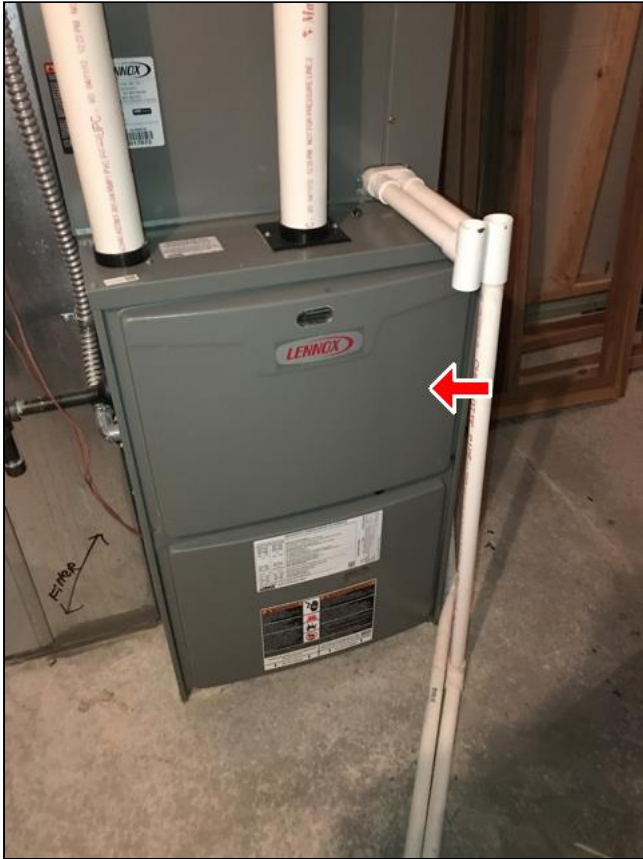
8.0 Item 1(Picture)

At the time of the inspection no deficiencies were noted with the operation of the furnace. The furnace was not checked for cracks in the heat exchanger or carbon monoxide leaks. Manufacture date is 2012. There is not a service record, I recommend having a qualified heating contractor service the furnace.

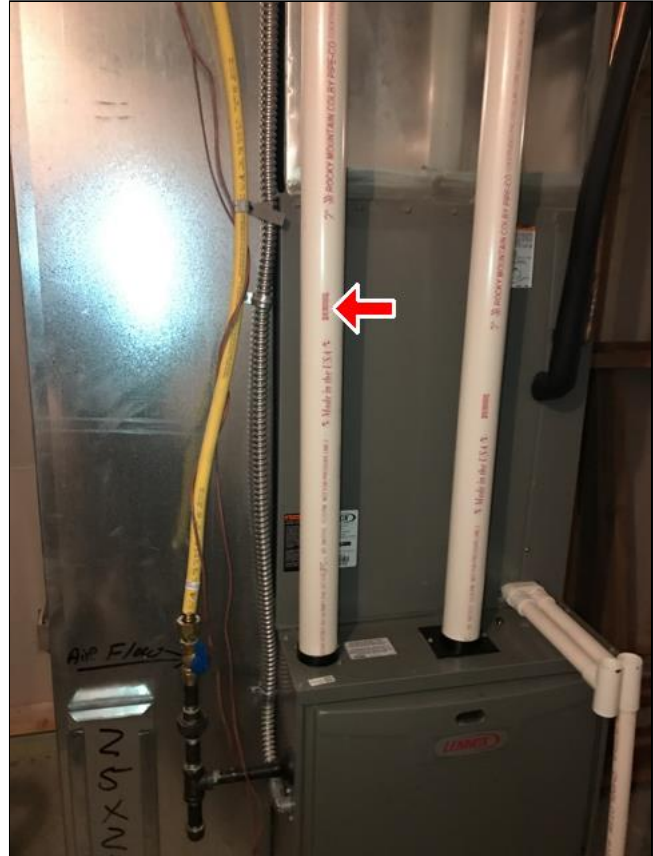
8.5 Item 1(Picture)

⊕ The Subject Property has Cellular Core exhaust piping for the furnace. The manufactures never intended this type of piping to be used to exhaust gas fired appliances. The piping can break down over time and crack, allowing carbon monoxide to enter the living space. We recommend having the piping inspected and certified or replaced with solid Schedule 40 pipe, by a qualified HVAC contractor. At the time this home was built it met code and there are still several building departments that allow this type of piping to be used as gas fired appliance vents, but because there have been several building departments that will no longer accept this type of piping and case studies of potential break down when heat is introduced, we will call this out as a safety concern. At a minimum we recommend having a Carbon Monoxide Detector installed in the furnace/water heater area.

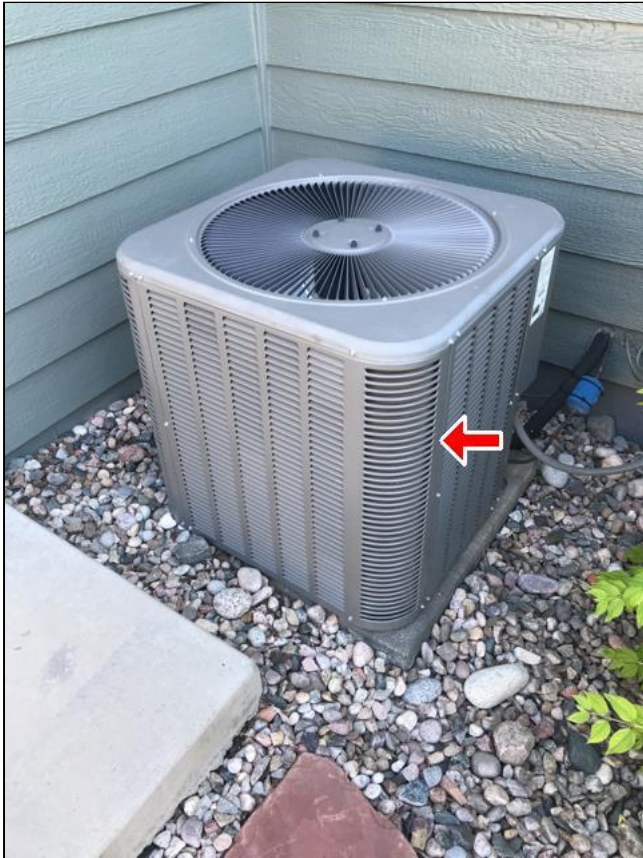
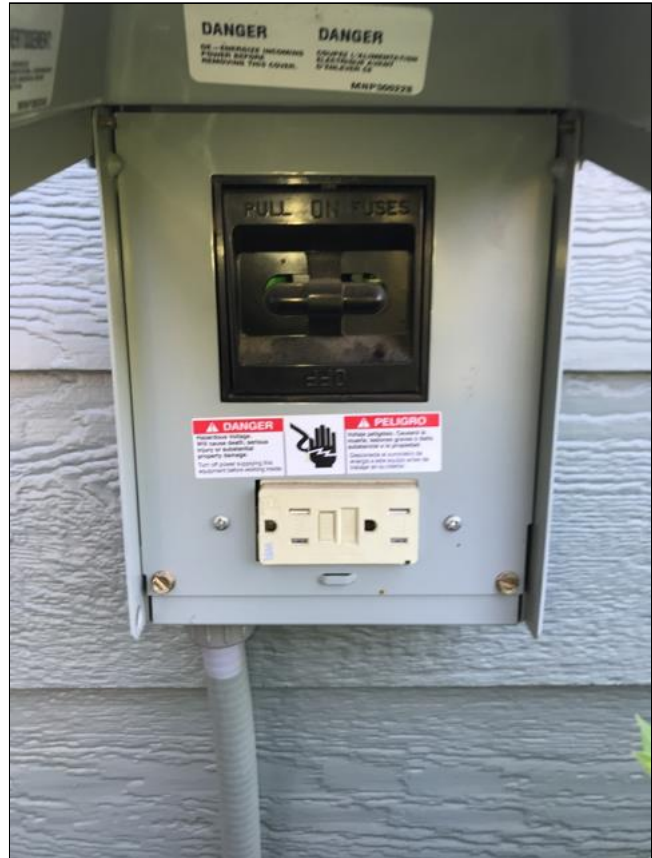
8.9 Item 1(Picture)

At the time of the inspection there were no deficiencies noted in the operation equipment of the A/C unit. Unit was Manufactured in 2012.

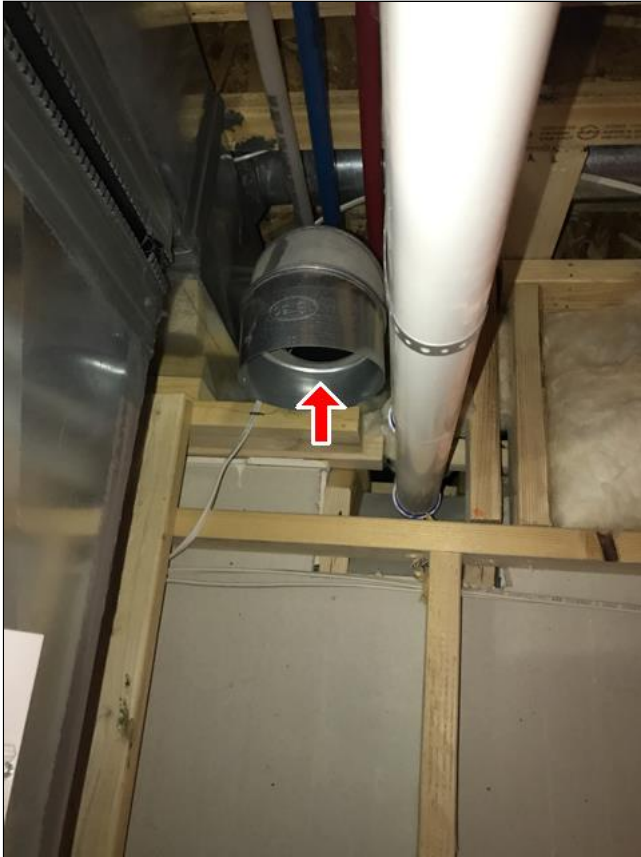
8.12 Item 1(Picture)

At the time of the inspection there was a nonrestricted operational outside combustable air source. This piping is required for outside combustable air (make up air) for your furnace/water heater. You will feel cold air in the winter, do not plug this air piping.

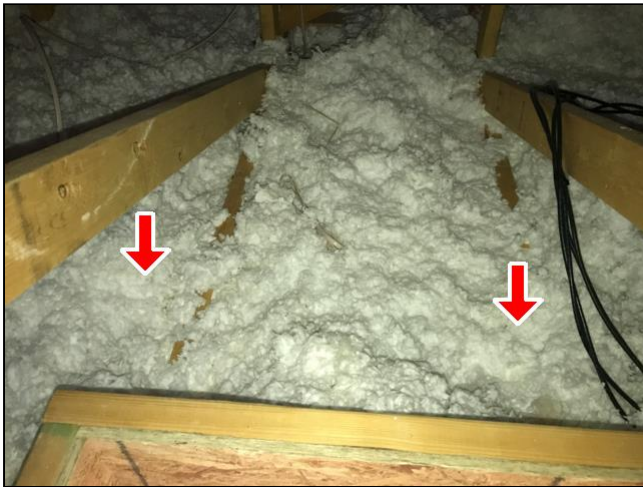
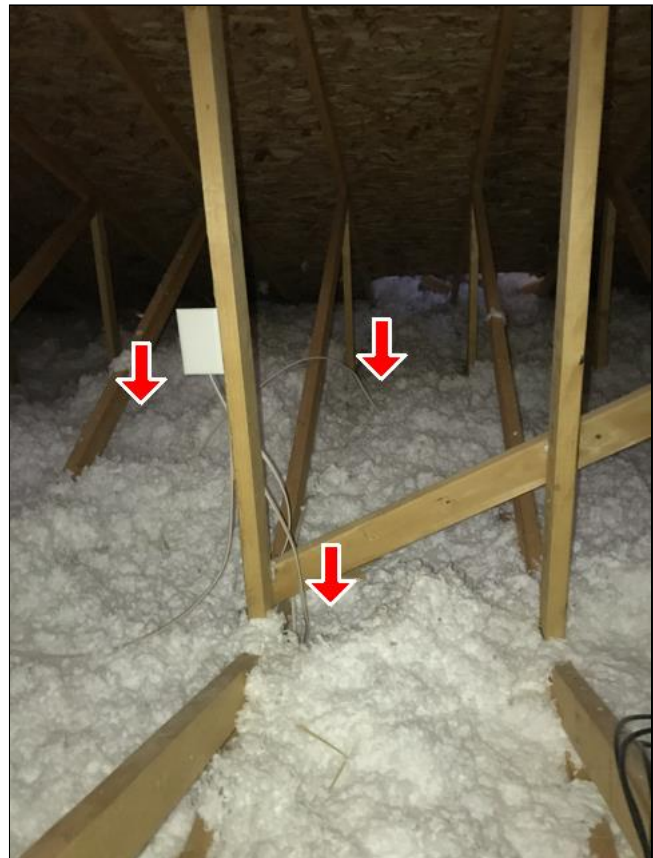
9.0 Item 2(Picture)

🏠 (2) The insulation in the attic has been walked on and has been compacted, and pulled back in areas. This causes the insulation to decrease its R value. It is recommended that a qualified insulation contractor evaluate and repair.

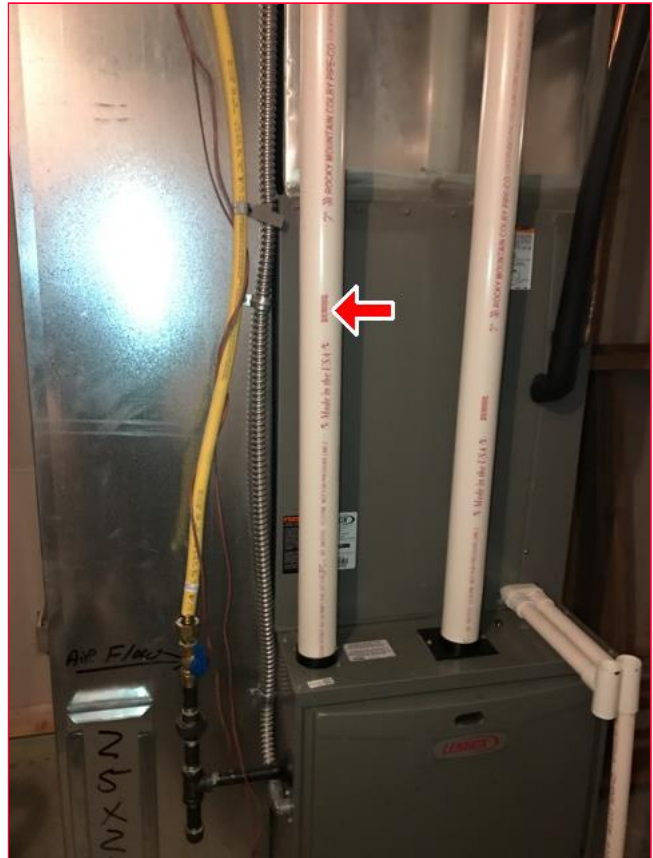
8.5 Item 1(Picture)

- +** The Subject Property has Cellular Core exhaust piping for the furnace. The manufactures never intended this type of piping to be used to exhaust gas fired appliances. The piping can break down over time and crack, allowing carbon monoxide to enter the living space. We recommend having the piping inspected and certified or replaced with solid Schedule 40 pipe, by a qualified HVAC contractor. At the time this home was built it met code and there are still several building departments that allow this type of piping to be used as gas fired appliance vents, but because there have been several building departments that will no longer accept this type of piping and case studies of potential break down when heat is introduced, we will call this out as a safety concern. At a minimum we recommend having a Carbon Monoxide Detector installed in the furnace/water heater area.

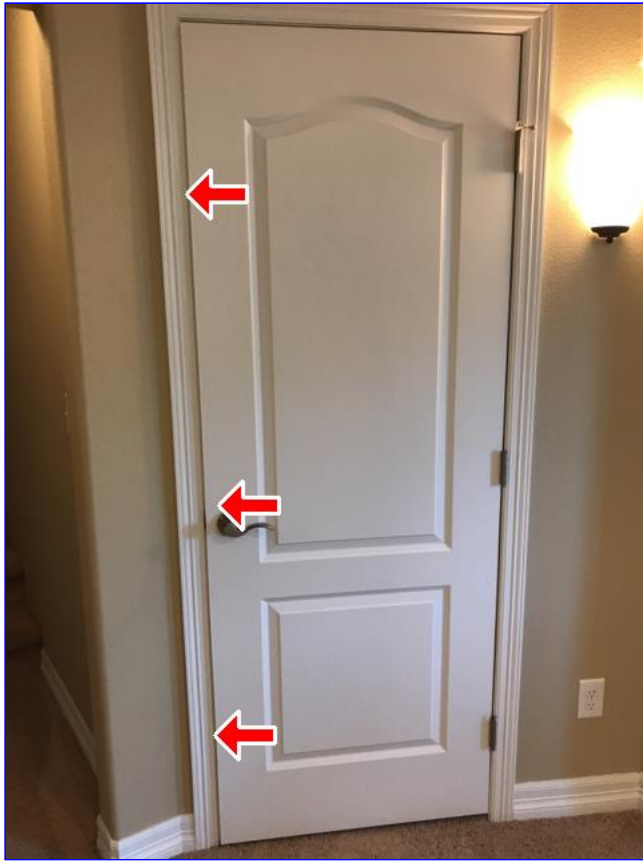
4.6 Item 5(Picture)

(3) Basement under the stairs storage closet door(s) rubs at jamb when operating. A qualified person should repair or replace as needed.

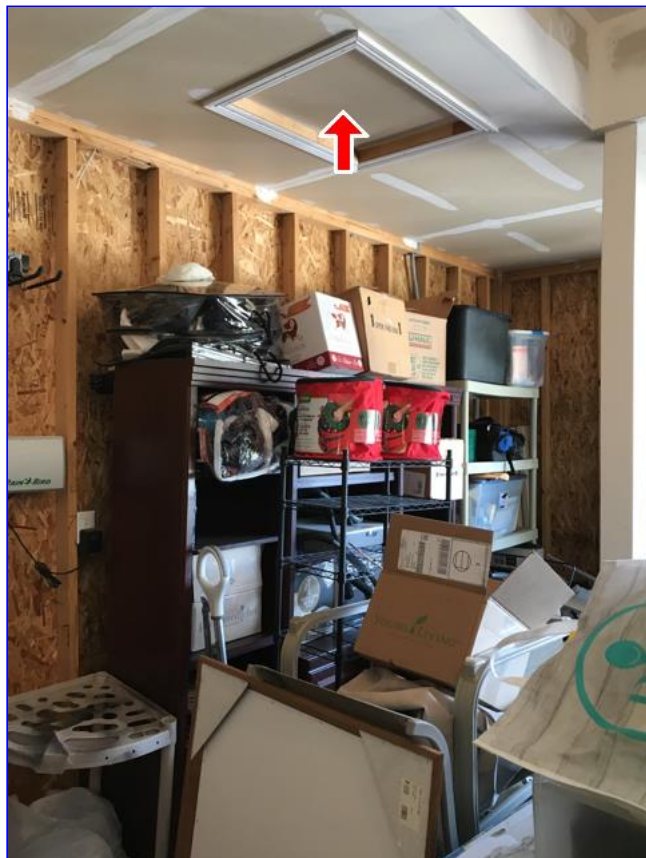
5.5 Item 7(Picture)

(2) The attic access in the garage was blocked by the seller's personal property. I could not inspect the interior side of the roof structure or insulation or any electrical in the attic.

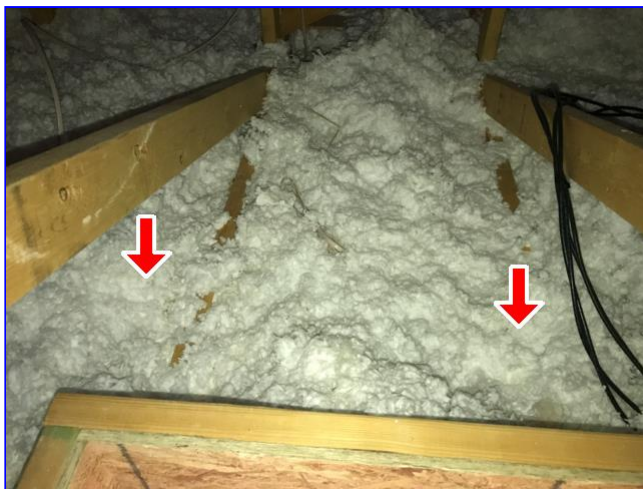
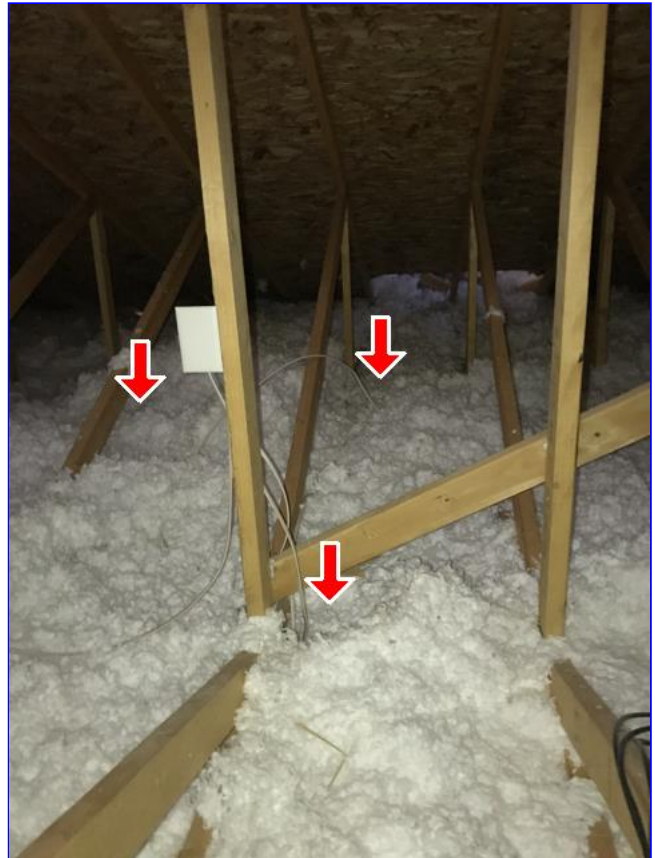
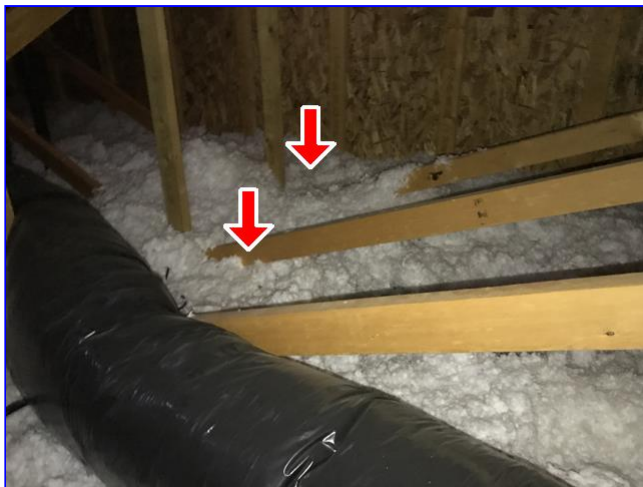
9.0 Item 2(Picture)

(2) The insulation in the attic has been walked on and has been compacted, and pulled back in areas. This causes the insulation to decrease its R value. It is recommended that a qualified insulation contractor evaluate and repair.

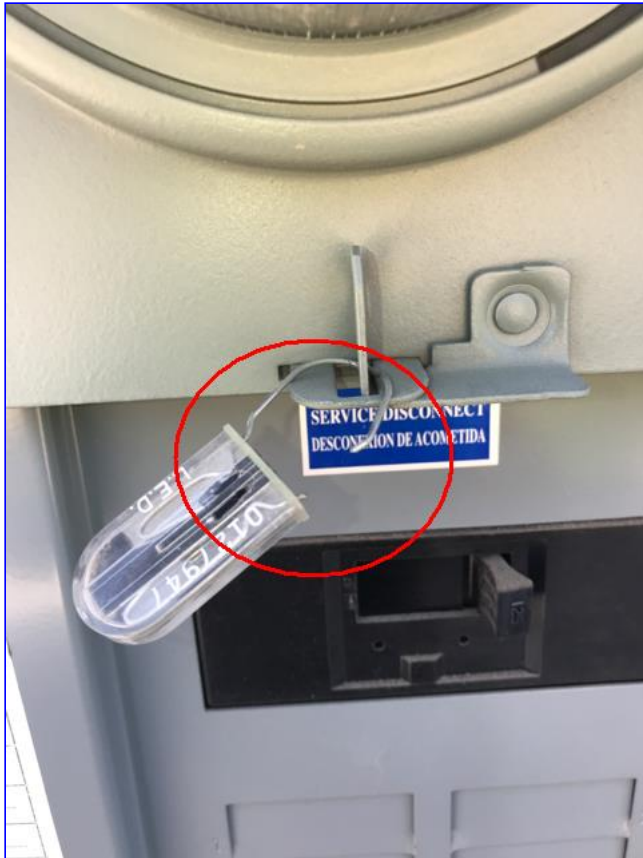
7.1 Item 10(Picture)

(4) The non-tamper clip on the meter housing has been clipped. I recommend that the Electrical Power Company be notified to inspect the meter and confirm that it has not been tampered with and install a new clip.

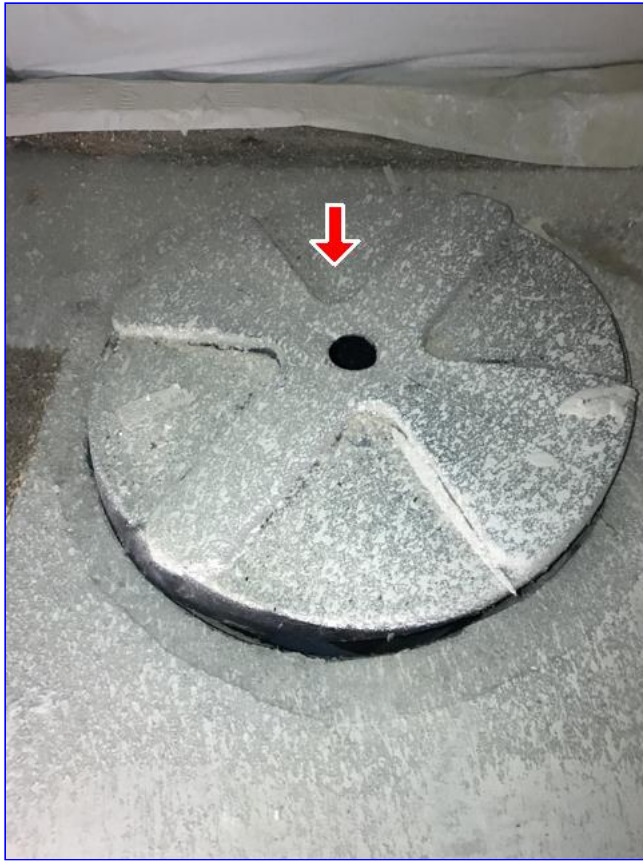
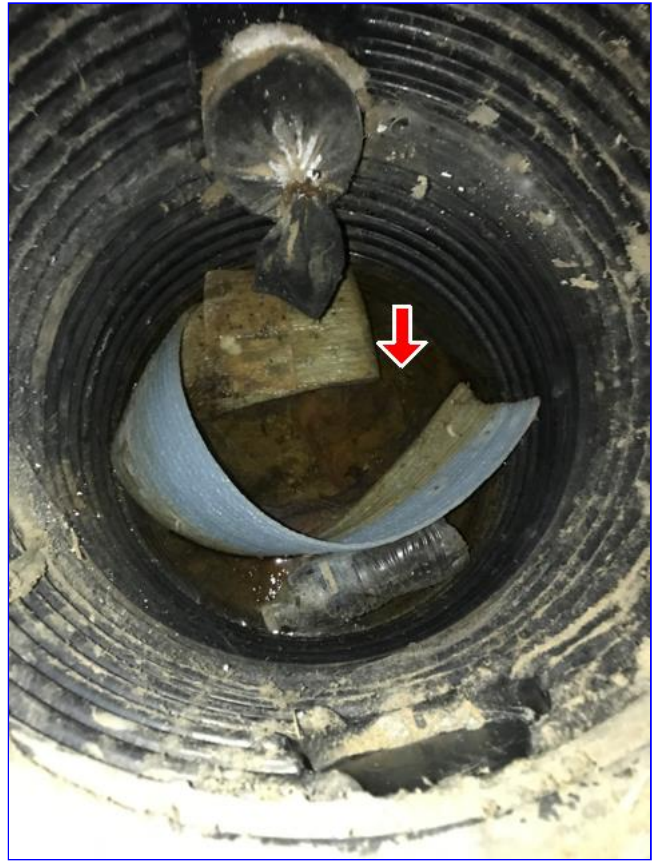
6.6 Item 1(Picture)

At the time of the inspection 4" of standing water and debris was noted in the sump pit and no pump was present. It is recommended that a pump be install and discharged to the exterior of the home. Discharge pipe needs to drain water 4-5 feet away from the home.
