Property Inspection Report

5619 Osbourne Dr, Windsor, CO 80550

Date of Inspection: 3/18/2022 Time: 9:00 AM

This is a 5 point home inspection covering roof, structure, electrical, plumbing, HVAC

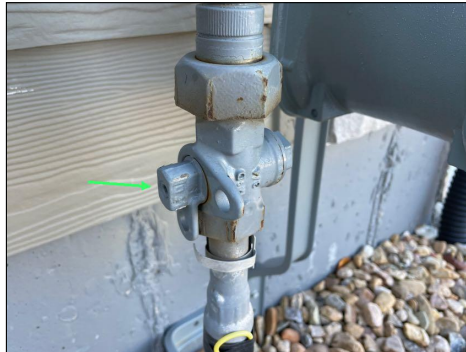
Main gas supply valve for the home

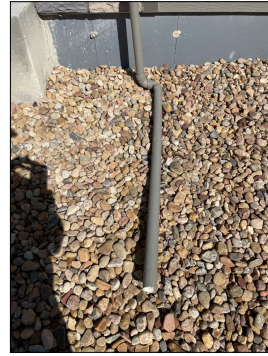
Sump pump discharge line on the south side of the home

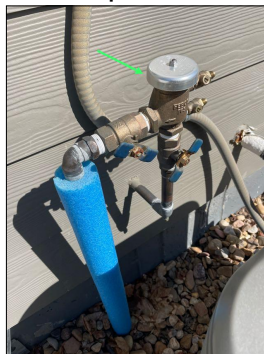
Irrigation back flow device noted as in place and an approved device

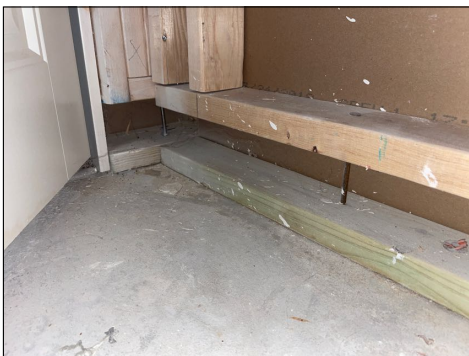
Walls are noted as properly floated

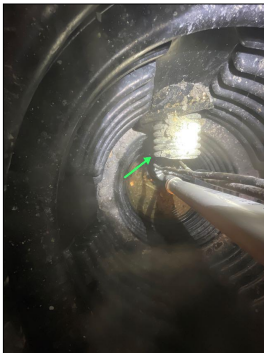
Foundation perimeter drain ports into the sump pump

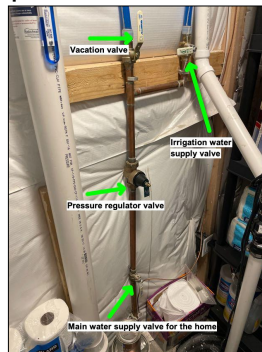
Main water supply entrance to the home is located in the basement storage room

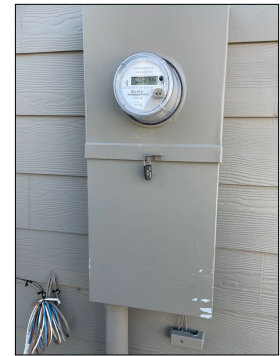
Main panel is located here, on the north exterior wall of the garage

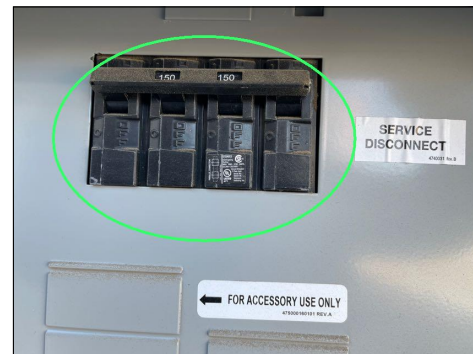
Main electrical service disconnect breaker for the home is located here in the main panel on the north exterior wall of the home

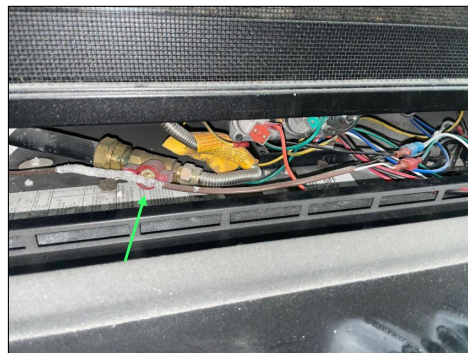
Gas supply valve for the fireplace is located here in the control area, just underneath the firebox
