Property Inspection Report

5619 Osbourne Dr, Windsor, CO 80550

Date of Inspection: 3/18/2022 Time: 9:00 AM

This is a 5 point home inspection covering roof, structure, electrical, plumbing, HVAC

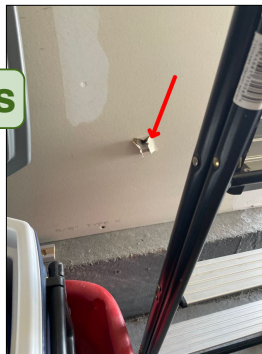
- **"DEFICIENCIES / CONCERNS"**
- The fire resistance sheathing that separates garage from heated / habitable living space is compromised. This is considered unsafe until corrected as the sheathing provides up to a one-hour fire barrier to protect the home from garage born fires and allow the occupants adequate time to escape. As well the firewall provides first responders time to protect and evacuate the occupants and home in such an occurrence. This is a safety and fire concern, and we recommend contacting a licensed contractor for repair as needed.

Firewall is compromised, recommend patching with drywall mud or fire resistant foam

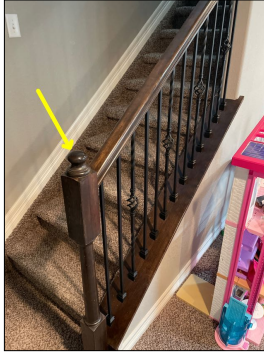
- Basement hand rail is loose or detached from the wall, have a contractor evaluate and repair as needed.

- Basement handrail is separating at a corner joint. Recommend contacting a licensed contractor for repair / correction as necessary.

Loose / wobbly

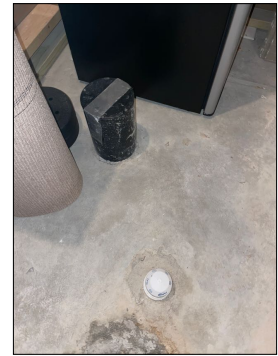
Active radon mitigation system, suction gauge should be calibrated annually and read between 3/4 cfm - 1.5 cfm to indicate the system is working correctly.

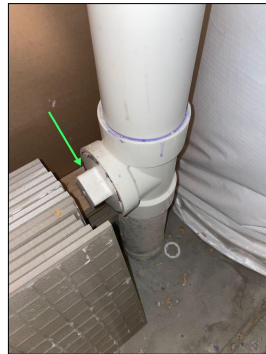
Main waste water line cleanout is located here in the basement utility room

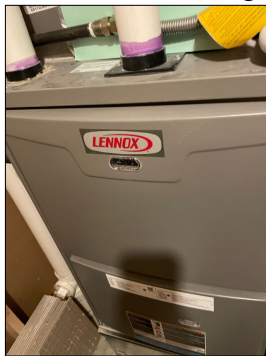
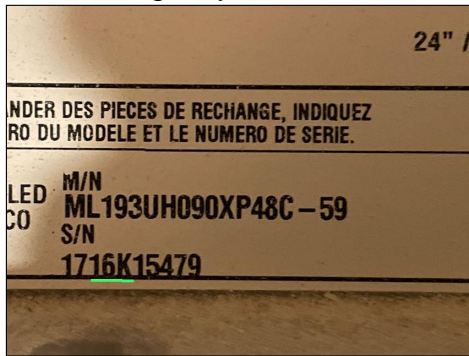
The Lennox high efficiency gas forced air furnace was manufactured October 2016 and is thus 5 years old currently

The furnace is very clean and in good serviceable condition

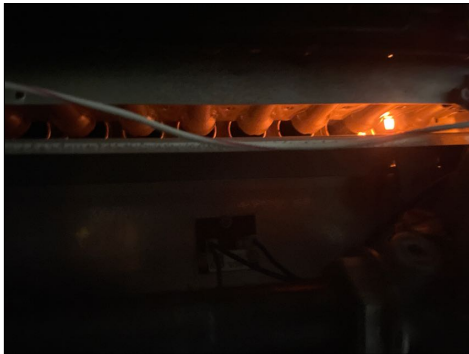
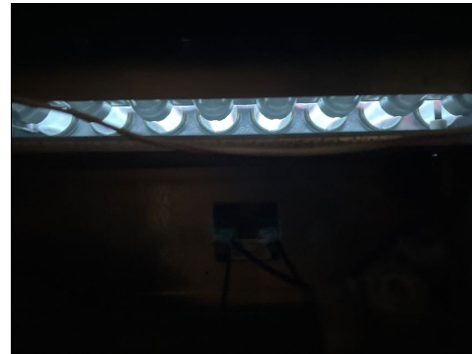
Glow plug properly activated from the thermostat at time of inspection

Gas jets fired up as intended burning a clean and crisp blue flame

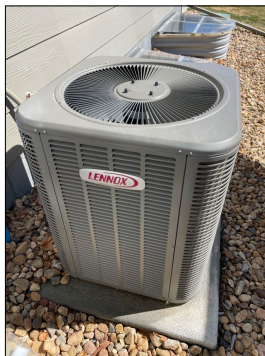
The Lennox electric AC condensing unit was manufactured November 2017 and is thus 4 years old currently

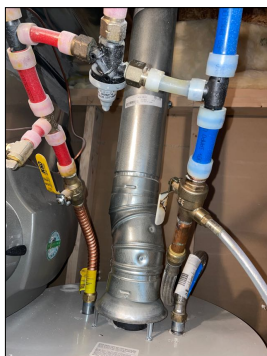
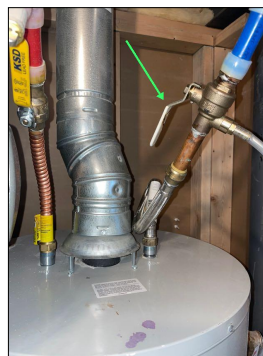
Water supply valve for the water heater is located here, just above the tank

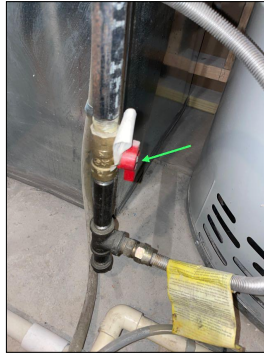
Gas supply valve for the water heater is located here, just to the left of the tank

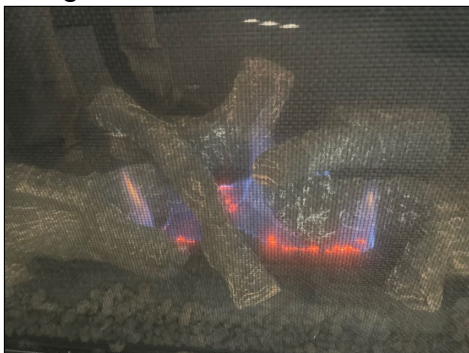
Gas supply valve for the fireplace is located here in the control area, just underneath the firebox

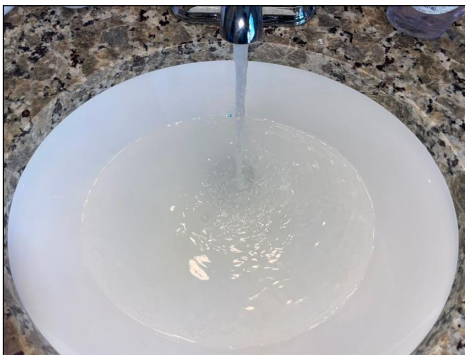
Upstairs common bathroom shower

- **"SUPPLY"**
- The water supply components operated normally at time of inspection.
- **"DRAINS"**
- The visible portions of the sink drains in the bathroom appear to be functioning as intended at the time of this inspection with notable exceptions listed below.
- **"DEFICIENCIES / CONCERNS"**
- **Slow drain in two of the upstairs bathroom sinks noted. Recommend clearing.**
